# Livestock carrier loss of propulsion entering Fremantle

THE following report was published by the Australian Transport Safety Bureau (ATSB) on 4 September 2025: *Australian Transport Safety Bureau – Loss of propulsion while entering the Port of Fremantle involving Al Messilah: 2 km from Fremantle, Western Australia, on 4 March 2025*

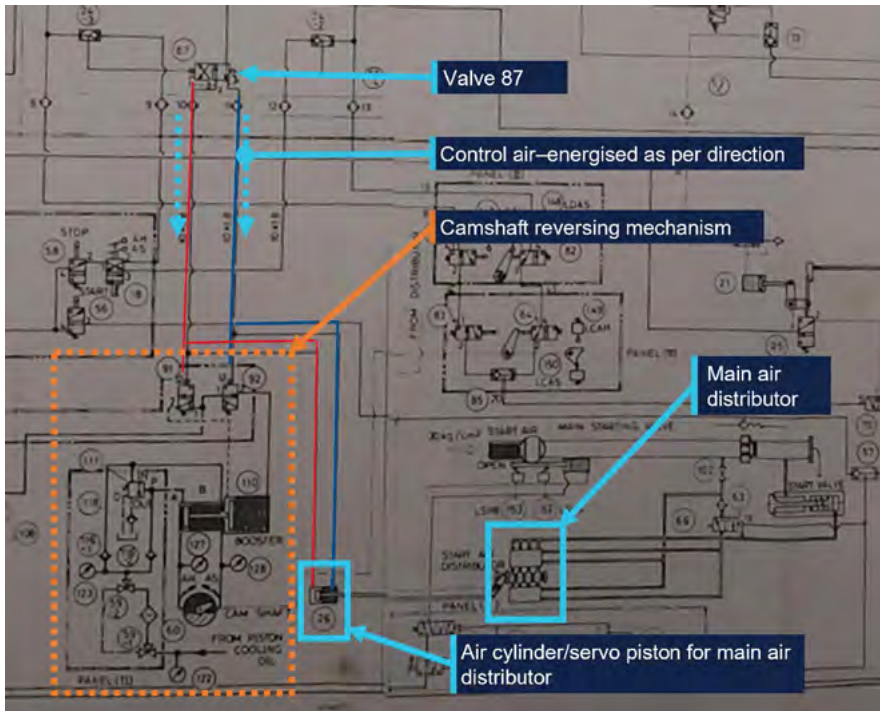
Figure 2: Pneumatic system Note: The blue line is showing the path of the control air in the AHEAD line and the red line is showing the path of the control air in the ASTERN line. (Source: Ship’s manager, annotated by the ATSB)

The investigation found that degraded seals inside the servo piston allowed control air to leak between the AHEAD and ASTERN chambers of the reversing air cylinder. This leakage introduced air into the ASTERN line of the camshaft reversing mechanism.

This likely resulted in the system not being able to maintain the control air pressure needed to fully actuate and hold the camshaft in the AHEAD position. The camshaft then likely moved to an indeterminate position, which misaligned the fuel injection and exhaust valve timing. The result was in the engine misfiring and stopping.

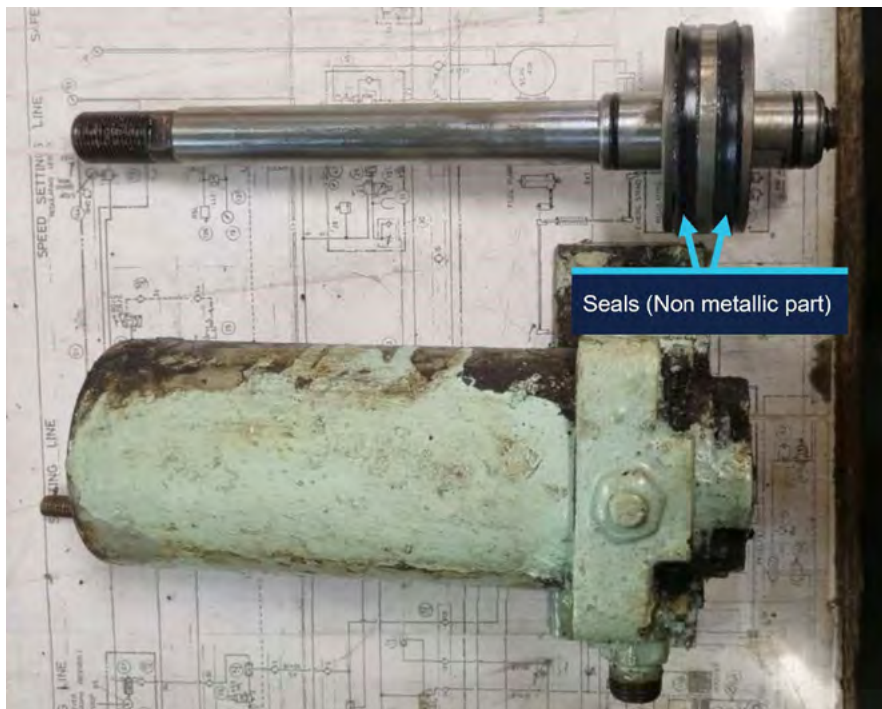
During maintenance conducted after the incident, it was identified that the seals on the servo piston of the main air distributor reversing cylinder had disintegrated.

Figure 5: Main air distributor reversing cylinder/servo piston with new seals. Note: The image shows the piston after the seals had been replaced. (Source: Ship's manager, annotated by the ATSB)

**Contributing factor** – While entering the Port of Fremantle, the main engine failed twice, most likely due to a failure of the seals in the servo piston of the main air distributor.

The affected seals were subsequently replaced by shipboard personnel once the ship was safely moored alongside (Figure 5).

The engine maker's service team attended the ship on 11 April 2025, inspected and overhauled the entire pneumatic manoeuvring system, including all of the pneumatic valves.
