# Survey to repair: turning findings into action

Phillip Fox of Midwest Marine Surveyors recently managed a case on the Midwest coast involving a serious incident on a bulk carrier: the failure of an SCR compressor.

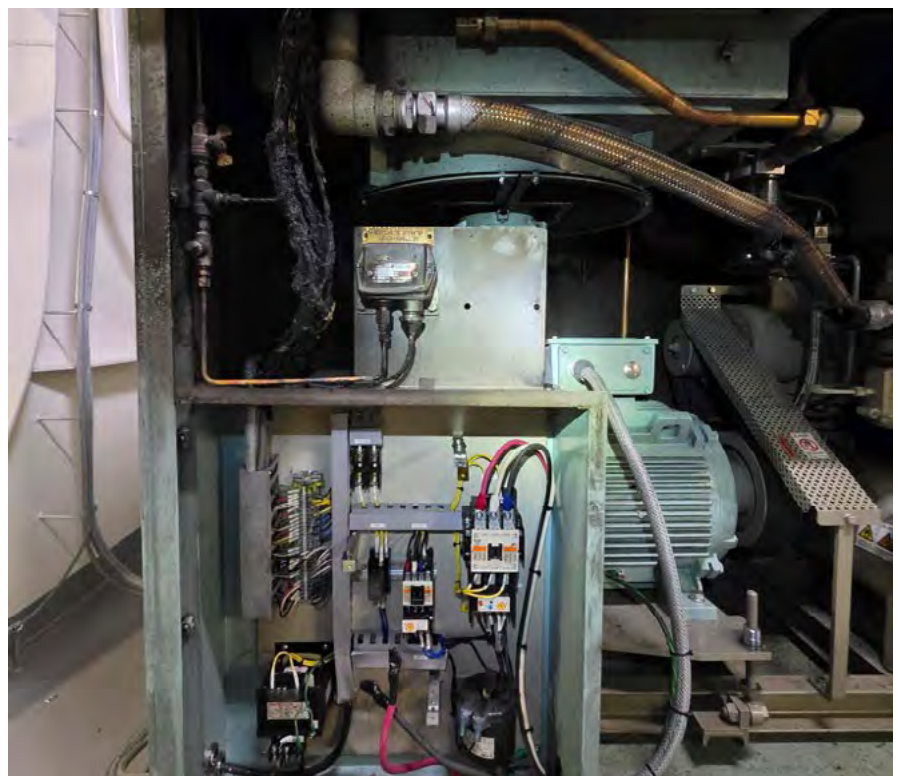
The vessel was boarded via local launch, and damage inspections revealed significant fire damage to the compressor unit and to the surrounding compartment's A60 fire insulation, a critical safety barrier in vessel construction. Without repair, the vessel was deemed unseaworthy.

Close inspection determined that a pneumatic high-pressure circuit failure had ignited the compressor's electrical wiring.

Compressor will be isolated by removing wiring from main switchboard in engine control room via circuit breaker for this unit. Circuit breaker to be tagged out and positively isolated with C/E having the key for the lock.

alarm system and heater system. Wiring to be taped up and isolated inside a plastic junction box or if easily accessible remove wiring harness from nearby junction box.

Compressor to be removed as one unit after confirmation from ships crew on dimensions and lifting requirements through hatches and then out of engine room with ships gantry or stores crane.

Pneumatic system to be isolated after removal of SCR unit.

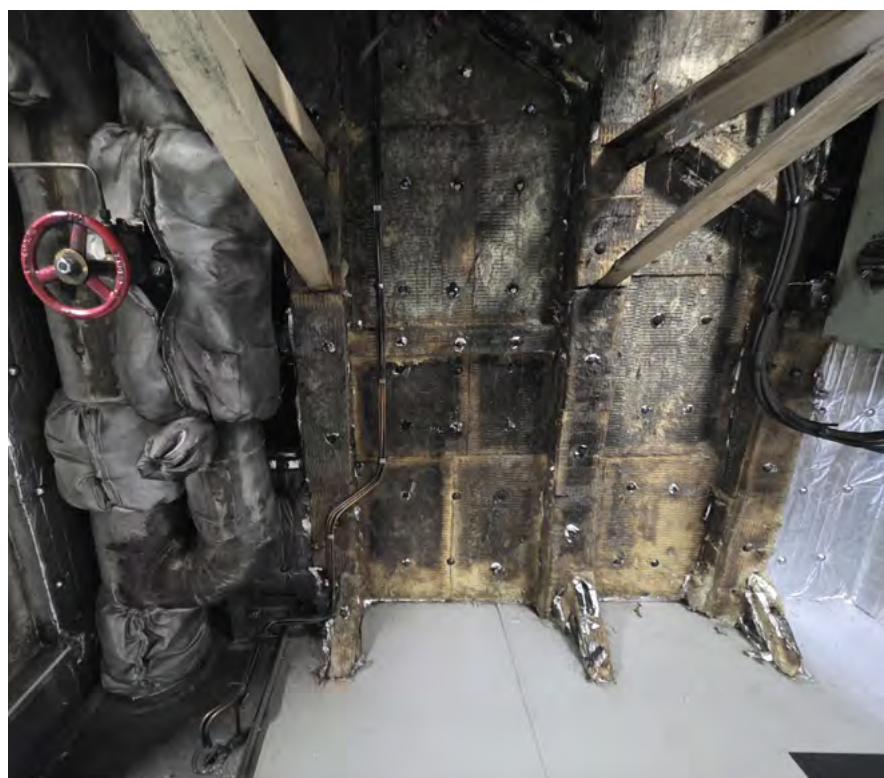
From the pictorial evidence of this case, the consequences of equipment and insulation failure were clear. However, through structured repair planning, the vessel was safely restored and returned to service.
