AUSTRALASIAN INSTITUTE  
OF MARINE SURVEYORS

March 2026

# MV *Island Trader* refloating report

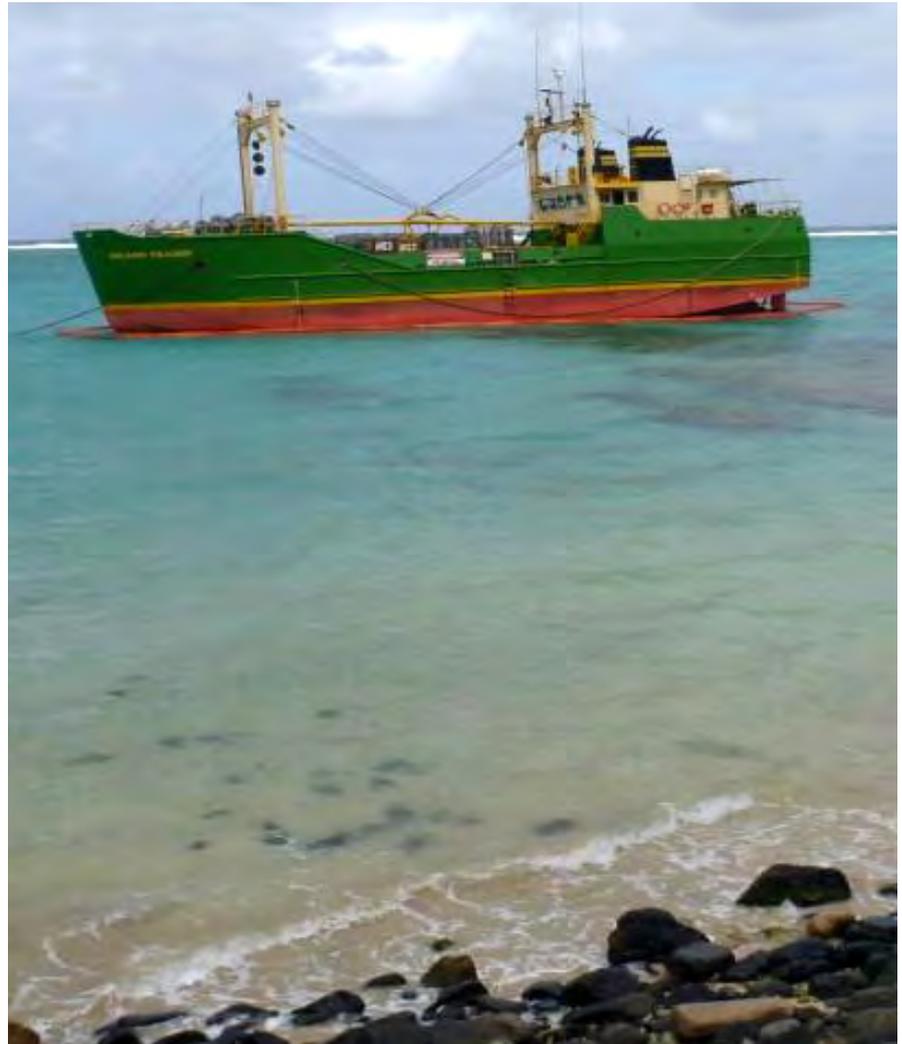
The ship's final resting position was 31o31.42' S, 159003.44'E, and the heading 1250T (1120C, T/E 13E). The vessel became firmly aground on calcareous sand and small platforms of Ned's Beach calcarenite beneath the after-body and abaft the wheelhouse.

The stranding occurred within the New South Wales Marine Park but well clear of any prescribed Sanctuary Zone or coral community. The calcarenite outcrop upon which the ship settled supported some small specimens of live coral (*Aeropora solitaryensis*) and algae and very few, if any, sedentary fish.

It is believed the grounding contributed infinitesimally to any natural weathering process. No noxious contamination to

*MV Island Trader stranded on calcareous sand and calcarenite outcrops. Note the oil boom encircling the ship.*

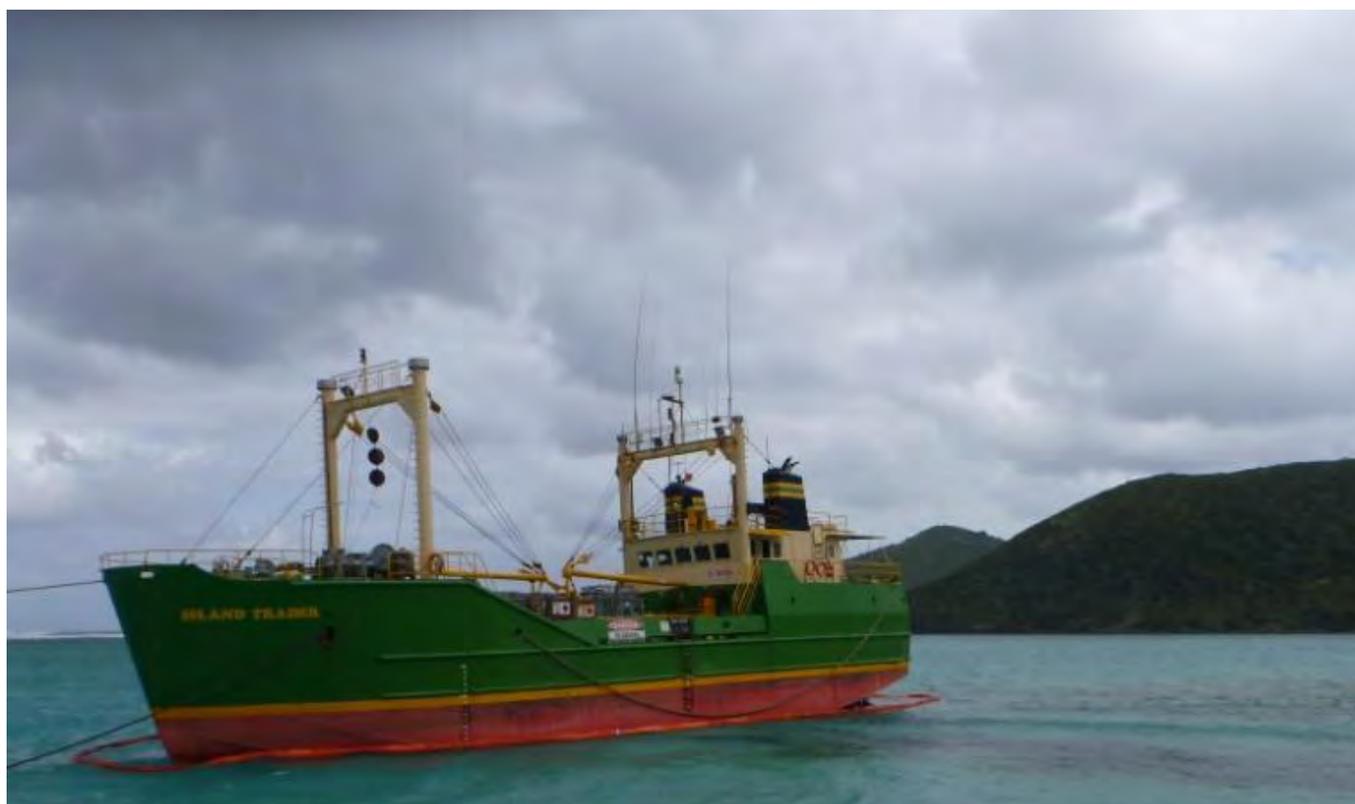
The port anchor had been laid out with approximately two shackles of cable and leading approximately 0930T.

A 56mm polypropylene hawser led approximately 1600T from the starboard bow Panama fairlead on the foc'sle head and had been secured to two anchors. Each of these anchors was on a separate chain leg diverging approximately 450 apart (bottom type: sand).

*MV Island Trader heeling to starboard and with port anchor laid out and a polypropylene hawser leading approximately 1600T from the starboard bow. Note also a boat rope rigged down the portside.*

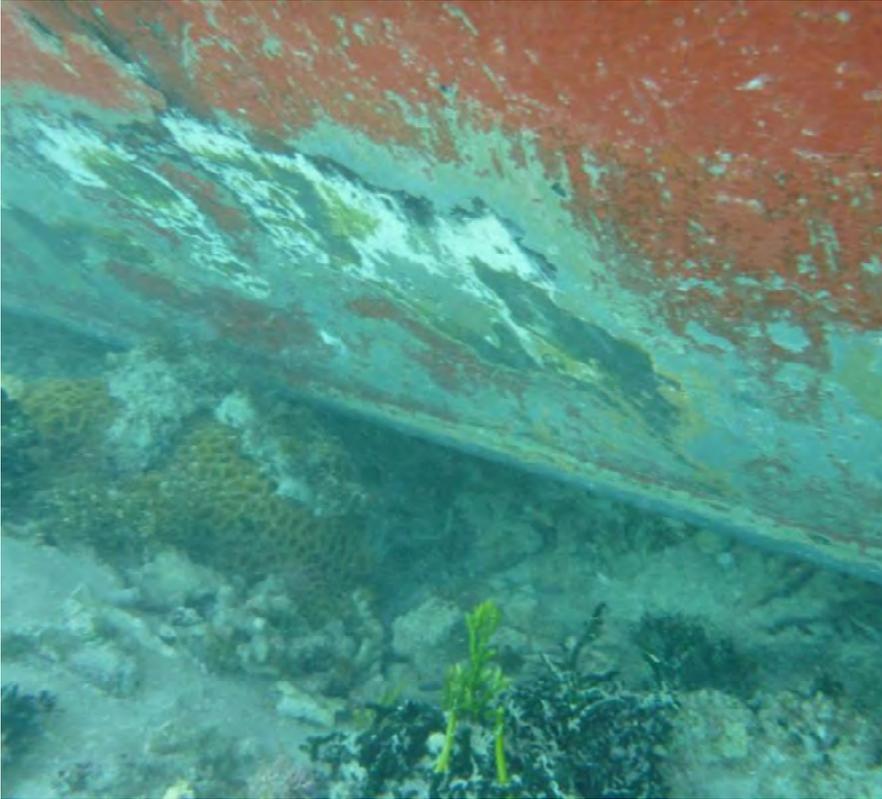
*MV Island Trader chine and topside plate at engine room level.*

No significant structural damage was deemed to have occurred, apart from some minor shallow indentation and paint loss.
