# Crew injuries during maintenance in engine room of *Wisdom Venture* near Sydney, NSW, on 6 May 2025

## 1. Investigation Summary

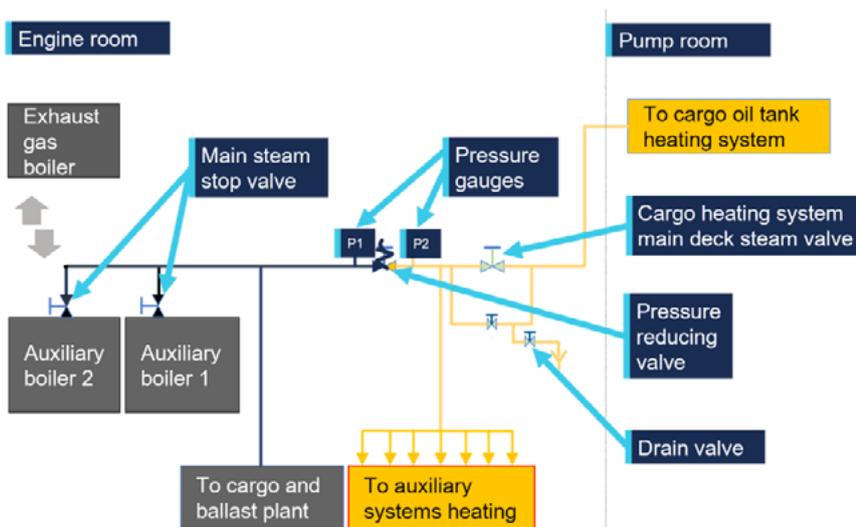
Figure 1: Simplified diagram representing the steam system.

P1: Pressure gauge before the reducing valve (high pressure side)  
P2: Pressure gauge after the reducing valve (low-pressure side)  
Black line shows high pressure steam. Yellow line shows low pressure steam. Exhaust gas boiler could be connected to any one of the auxiliary boilers through a water circulating pump.  
Source: ATSB

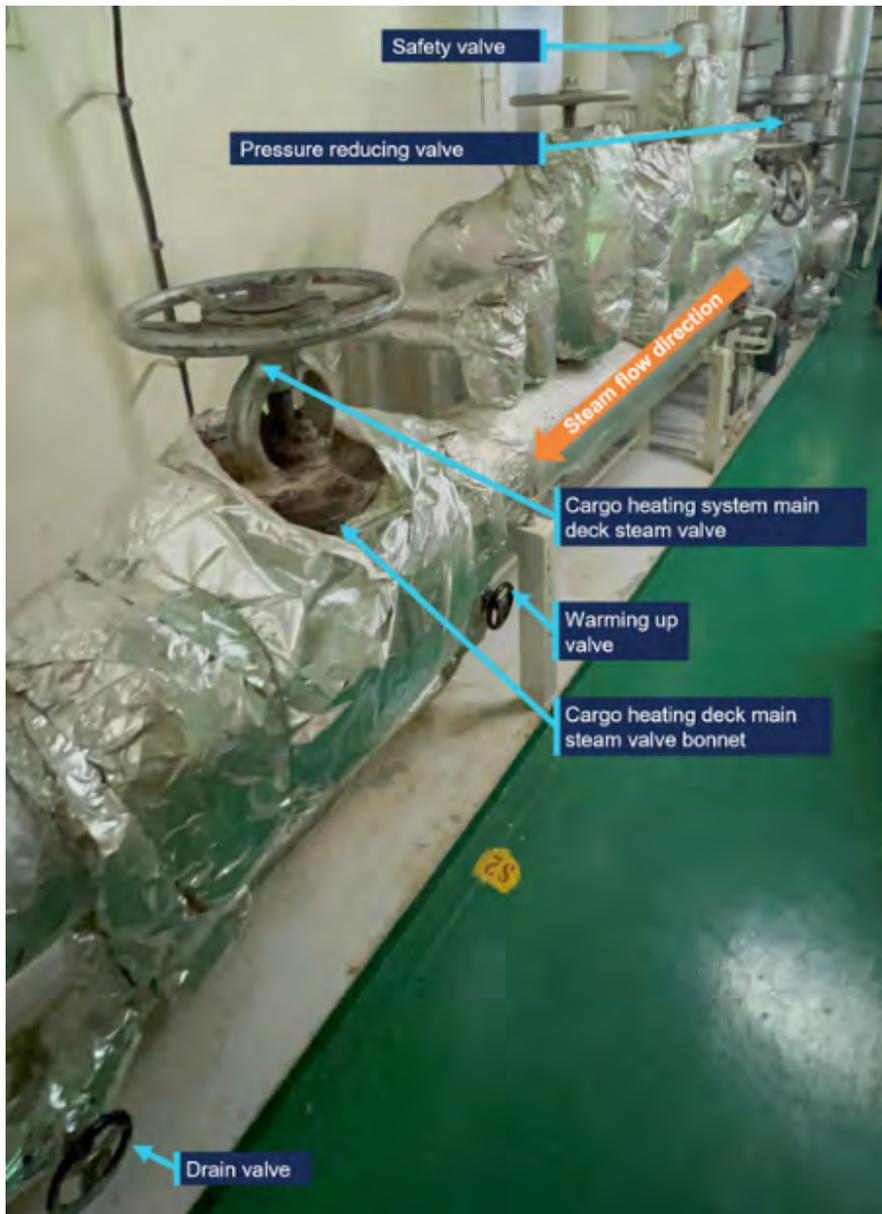
Figure 2: Cargo heating steam main line in engine room. (Source ATSB site photograph)

Low pressure steam passed through the main deck steam valve (Figure 1 and Figure 2), the last valve in the steam line in the engine room, which led to the deck and the cargo heating system. This valve was the main steam isolation valve for the cargo heating system. It was closed when cargo heating was not required and played a critical role in making sure the system could be safely shut down for maintenance and isolating the deck heating system during emergencies.

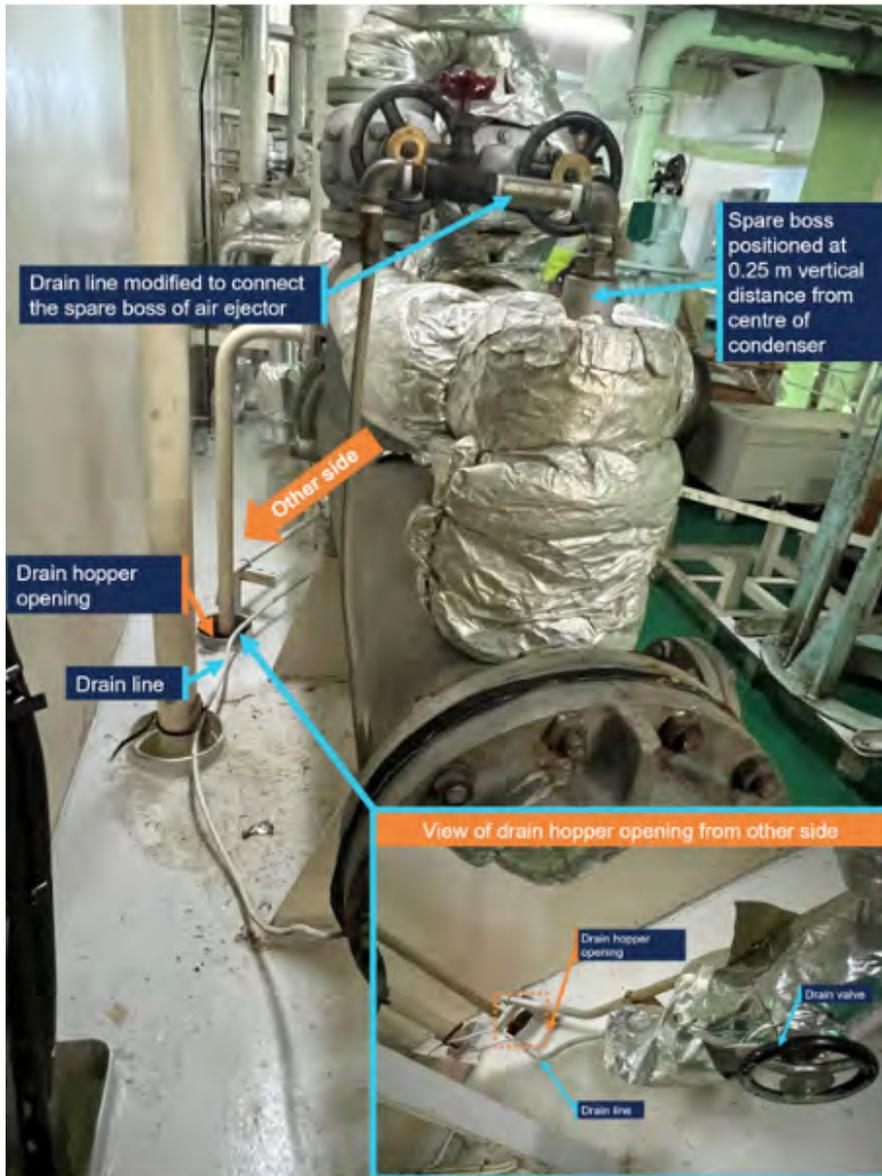
The ATSB also found that a drain line in the warm-up bypass line had been permanently modified without formal approval or documentation. This change was not incorporated into a risk assessment and no formal review was conducted.

This undocumented change likely introduced a system vulnerability that undermined the effectiveness of the steam system isolation.

During the site inspection, the ATSB identified a permanent modification to the drain line from the warming-up line (Figure 3). It was reported that the modification was to save water by redirecting condensate away from the open drain hopper (which led to the engine room bilges) and returning the water to the boiler feedwater system.

The condenser was at approximately the same vertical elevation as the stop valve, with the boss about 0.25 m above the condenser.

The connection was established using a fabricated pipe assembly comprising unions, elbows and a bronze union bonnet globe valve.

Figure 3: The modification connected the drain line to a spare boss<sup>4</sup> on the condenser for the air ejector. (Source ATSB site photograph)

In combination, this configuration did not allow for a positive visual confirmation that the line was free of steam or condensate. Consequently, when the valve bonnet was removed, residual hot condensate was released, resulting in significant burn injuries to three crew members.

drain line on *Wisdom Venture* has been returned to its original design configuration. A fleetwide campaign has also been initiated to identify any unauthorised modifications to shipboard piping systems. Where such modifications are identified, internal investigations will be conducted.
