AUSTRALASIAN INSTITUTE
OF MARINE SURVEYORS

Shipshape

March 2026

A novel approach to correcting a magnetic compass “stuck” on one heading throughout a 360° swing

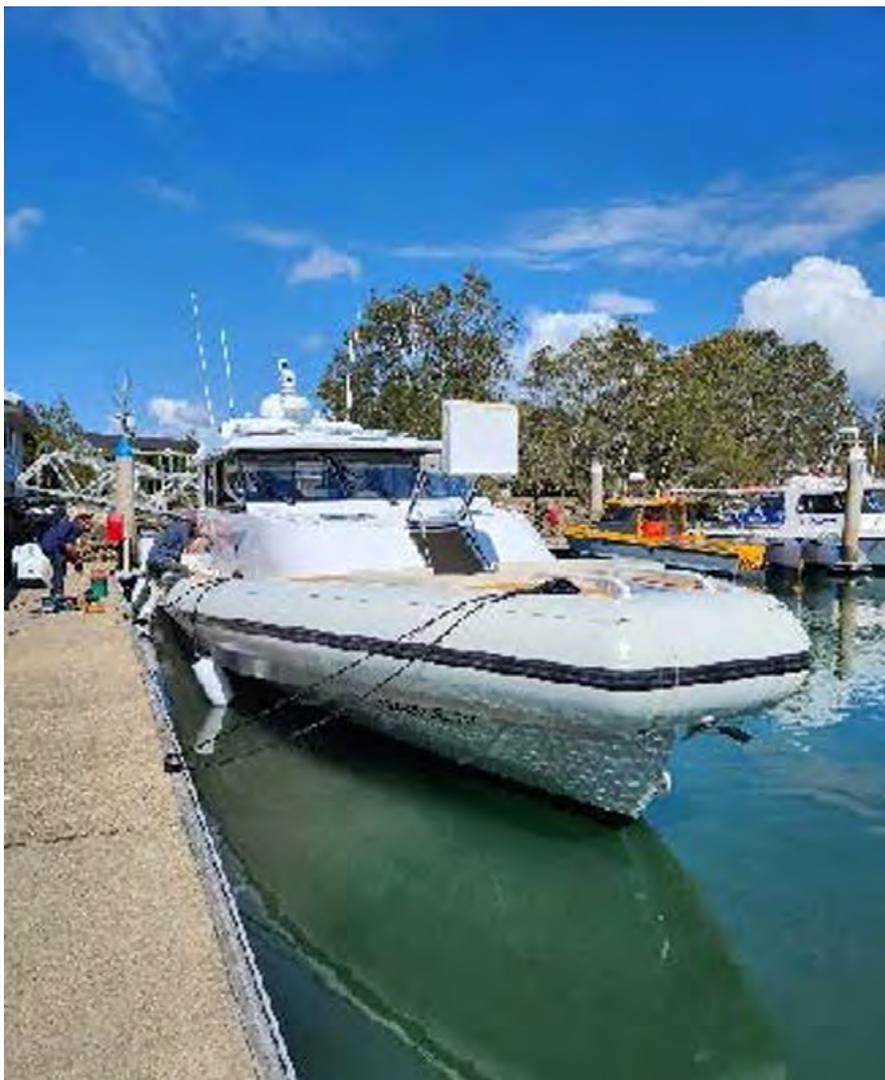
Figure 3: *A new-build 15-metre LOA foam-collared aluminium monohull.*

(Figure 3), it became evident the magnetic steering compass heading was “stuck” on East when swung through 360°.

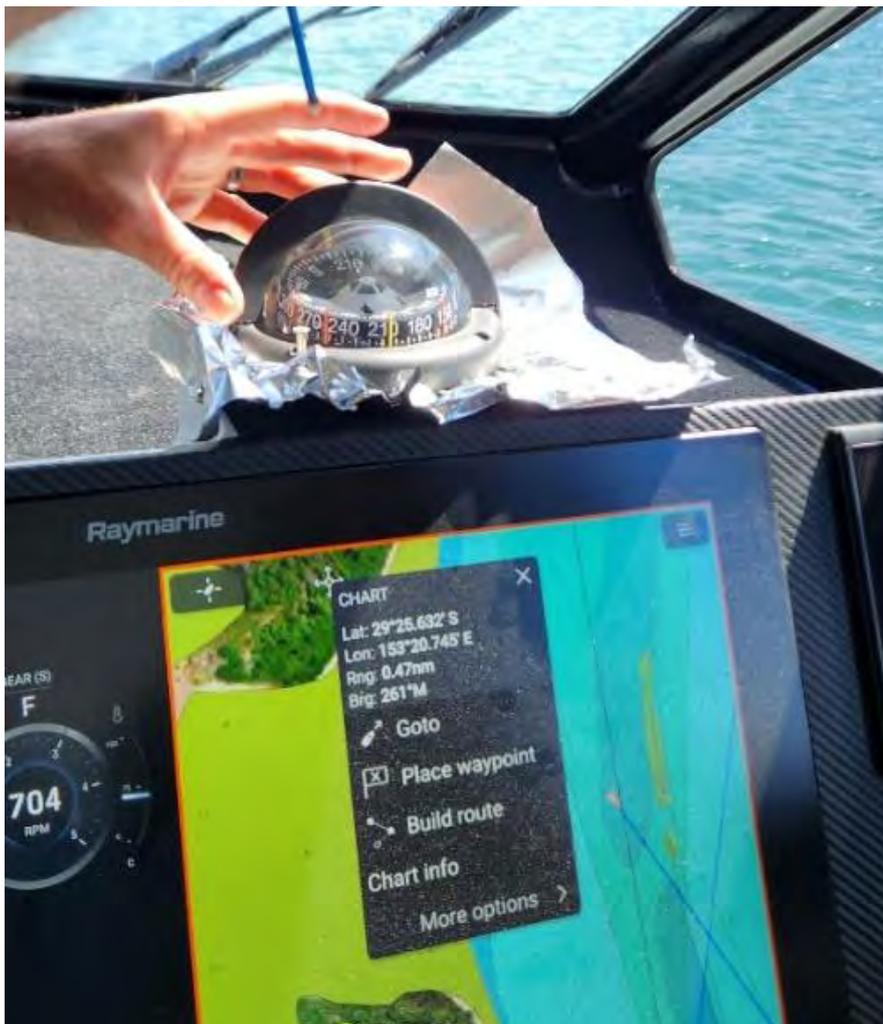
Figure 5: *The magnetic steering compass was removed from a circular hole in the console and a pocket (“cage”) was fashioned inside the hole using a sheet of aluminium foil and the compass reinstalled.*

The compass was removed from its intended place and found to work and behave as a normal compass. However, the builder was reluctant to move the compass away from the electronic devices deemed to be causing the “locked” compass. It seemed rational to conclude the compass was aligned with a very strong resultant electromagnetic field (Figure 4) directed athwartship, from starboard to portside.

Strategic positioning of powerful rare-earth magnets in the traditional manner had no effect and it was elected to try shielding the compass from the imagined, invisible electromagnetic field using a sheet of aluminium foil to create a quick, impromptu Faraday Cage (Figure 5).

Once completed, the compass was found to function normally and, following analysis, was corrected in the conventional way. The following coefficients were determined:

- Coeff A +0.375
- Coeff B Nil
- Coeff C +1.5
- Coeff D +1.0
- Coeff E +0.75
