# Shipshape

September 2026

# Cargo hatch covers set a challenge

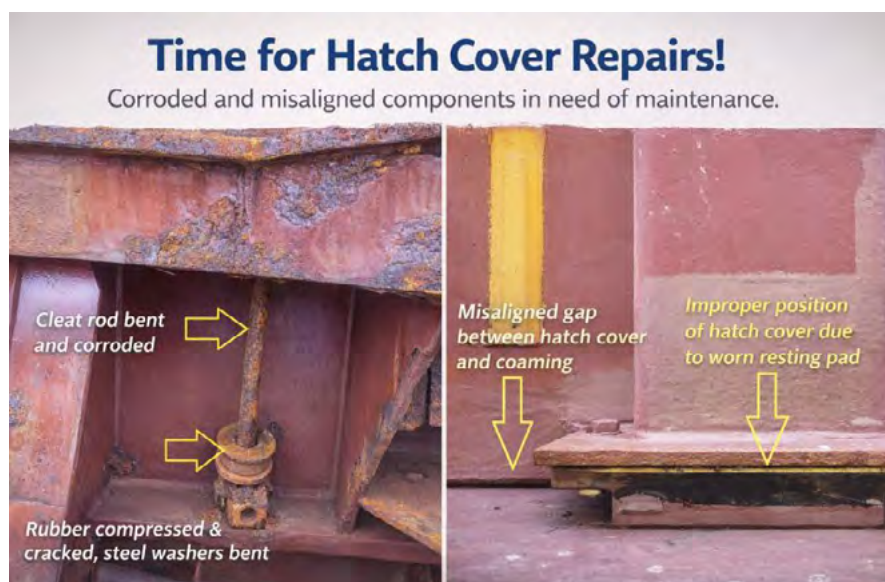
The mild steel of the lips was exhibiting a classic "rust pack" expansion. (Rusted steel can swell to several times its original thickness.) In this case, the flaking was physically pushing the rubber seal away from its original position.

Looking at the rubber, you could clearly see the permanent set (compression of the rubber) had moved from the centre of the rubber to the side.

We have to stop treating hatch covers like simple "lids". They are complex mechanical assemblies with millimetres of tolerance managed by bearing pads, locator and supporters. A hose test is just a static snapshot at the pier. It doesn't account for the dynamic racking and flexing of a hull in a seaway. If the sealing geometry is already fighting a misaligned "set" due to channel corrosion, that seal will struggle the moment the ship starts to work in heavy weather.

The bottom line: if we ignore "swollen" steel because the test passed today, we aren't maintaining a ship – we're just scheduling a more expensive

mechanical failure for tomorrow. When the alignment goes, the bearing pads take the brunt and a “watertight” seal becomes a dynamic failure very quickly.

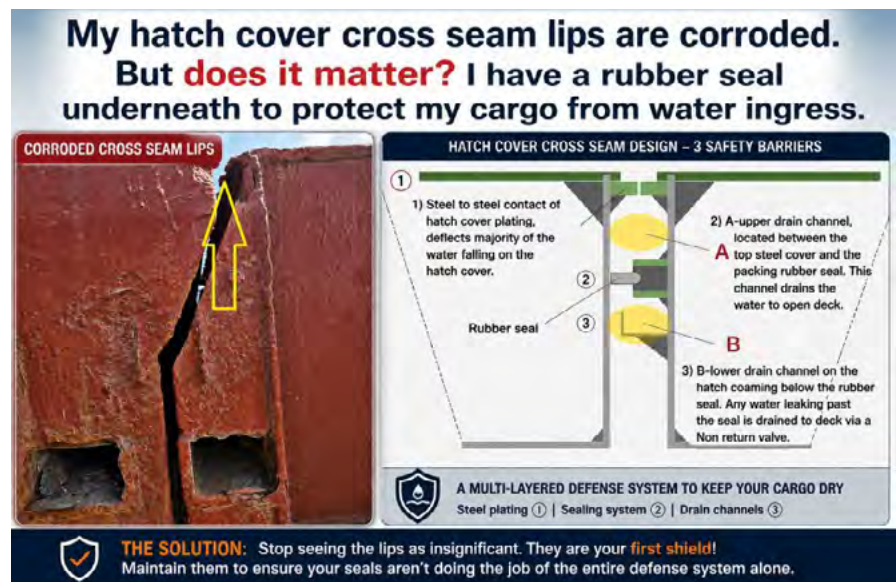
### Hatch cover cross seam lips are corroded

Let’s visualise how this system is actually supposed to work. Think of your hatch cover cross-seam as a multi-layered defence

Layer 1: the metal lip (the first warrior) – this is your primary defence. Its job is to deflect

the vast majority of water that crashes onto the hatch cover (say, during heavy weather).

Layer 2: the drain channel – any water that sneaks past that first lip is funneled into a drain channel located above your rubber seals.

Layer 3: the rubber seal (the final line) – ideally, these seals should prevent any water from passing through. However, as the ship rolls and pitches in heavy seas, the hatch covers experience slight movement. This can break the seal’s contact, allowing water to pass. Furthermore, with aging and the harsh marine environment, the rubber deteriorates over time, creating a high chance of water ingress.

Layer 4: the lower drain channel – because of these risks, there is a secondary drain channel positioned below the rubber seals to finally drain off any water that manages to make it past the seals.

The solution: stop seeing the lips as insignificant. They are your first shield! You need to maintain them to ensure your seals aren’t doing the job of the entire defence system alone.
