# Livestock carrier loss of propulsion entering Fremantle

THE following report was published by the Australian Transport Safety Bureau (ATSB) on 4 September 2025: *Australian Transport Safety Bureau – Loss of propulsion while entering the Port of Fremantle involving Al Messilah: 2 km from Fremantle, Western Australia, on 4 March 2025*

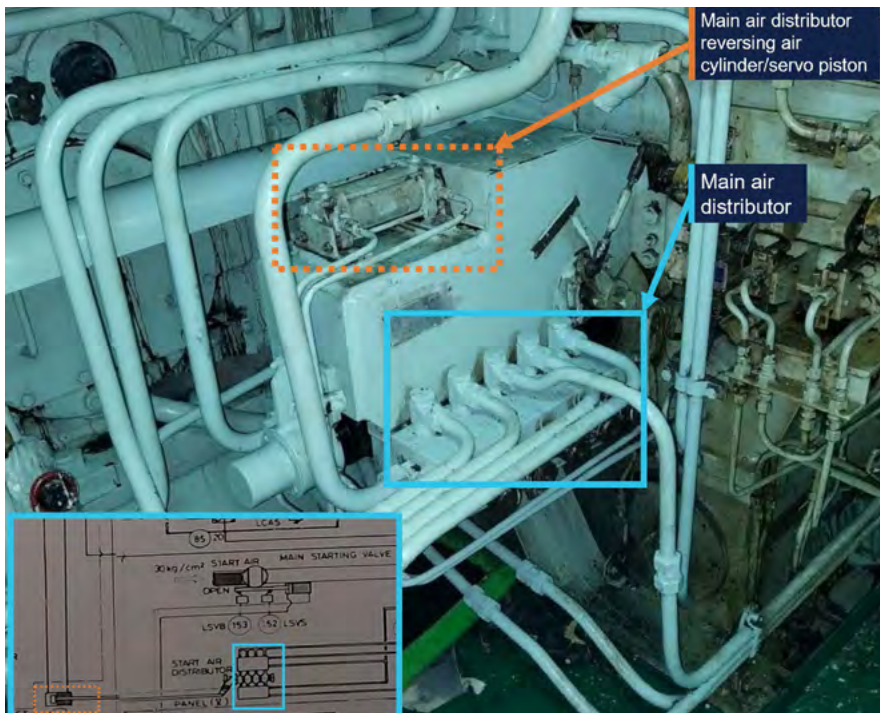
Figure 3: Main air distributor (Source: Ship’s manager, annotated by the ATSB)

the AHEAD or ASTERN line and acted on the servo piston (Figure 3). This piston moved the main engine air distributor into the correct position for the selected direction.
