# Survey to repair: turning findings into action

Phillip Fox of Midwest Marine Surveyors recently managed a case on the Midwest coast involving a serious incident on a bulk carrier: the failure of an SCR compressor.

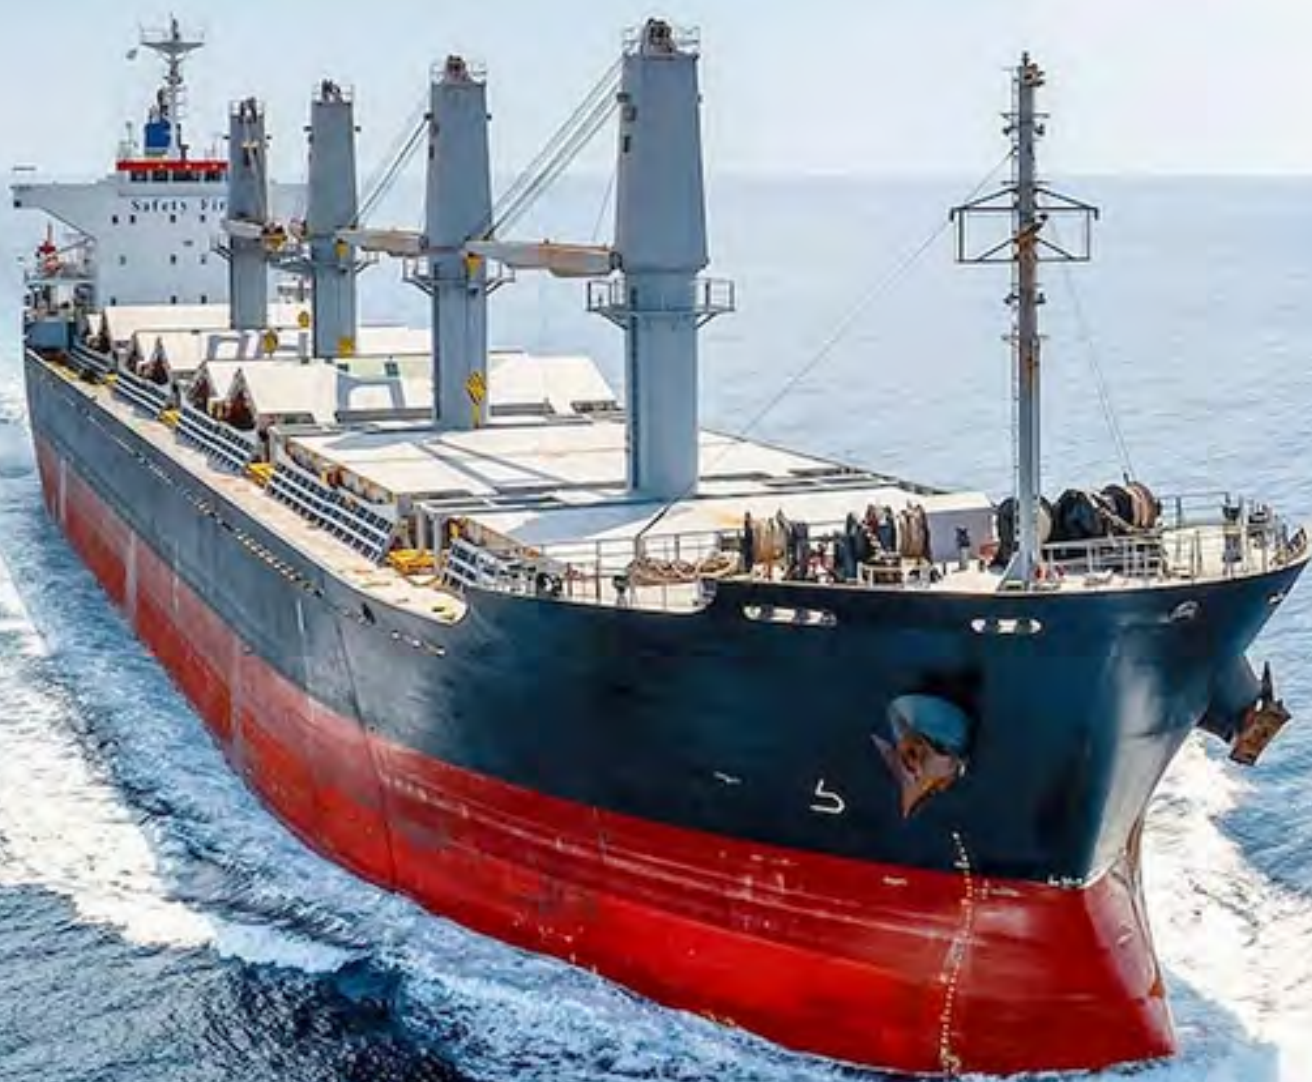
The vessel was boarded via local launch, and damage inspections revealed significant fire damage to the compressor unit and to the surrounding compartment's A60 fire insulation, a critical safety barrier in vessel construction. Without repair, the vessel was deemed unseaworthy.

Close inspection determined that a pneumatic high-pressure circuit failure had ignited the compressor's electrical wiring.

TK Marine Consultants, an AMSA-accredited surveying company with strong knowledge of international standards and insurance club requirements, worked alongside Midwest Marine Surveyors to deliver a structured repair plan and Inspection & Test Plan (ITP) utilising a recognised insulation company, Griffin Marine.

**Qualified Contractors** – The insulation replacement required LR or DNV-certified insulators.

**OEM Components** – Only OEM spare parts with IACS-type approval were quoted on the compressor. Using non-approved parts on a critical system could lead to litigation in the event of failure, damage or loss of life.
