AUSTRALASIAN INSTITUTE
OF MARINE SURVEYORS

Shipshape

March 2026

A novel approach to correcting a magnetic compass “stuck” on one heading throughout a 360° swing

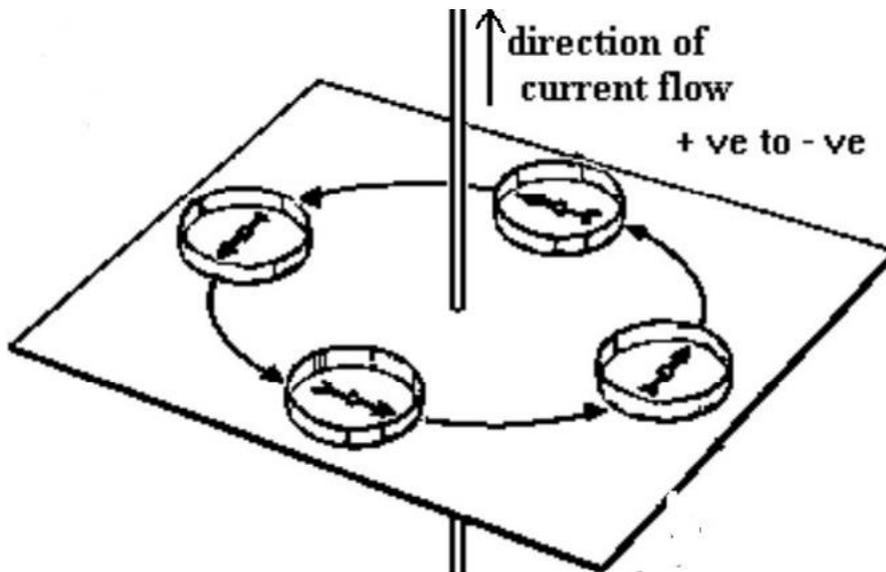
If a deviation causing magnetic field or electromagnetic field is stronger than the Earth’s magnetic field, then the compass needle will align itself to this new field (Figure 2).

Figure 2: *Current flowing through a wire will create an invisible magnetic field at right angles to the direction of the wire. This is validated by observing the deflection of a compass needle about the wire.*

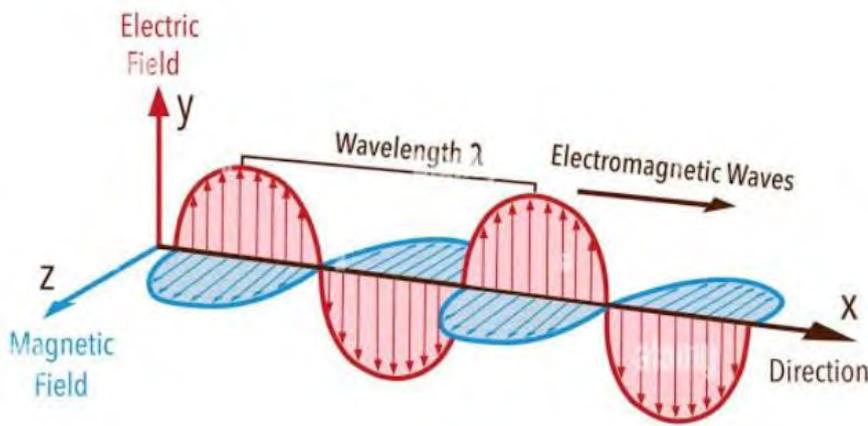
Figure 4: *Electromagnetic waves.*

The compass was removed from its intended place and found to work and behave as a normal compass. However, the builder was reluctant to move the compass away from the electronic devices deemed to be causing the “locked” compass. It seemed rational to conclude the compass was aligned with a very strong resultant electromagnetic field (Figure 4) directed athwartship, from starboard to portside.

Strategic positioning of powerful rare-earth magnets in the traditional manner had no effect and it was elected to try shielding the compass from the imagined, invisible electromagnetic field using a sheet of aluminium foil to create a quick, impromptu Faraday Cage (Figure 5).
